Forest
Service

Santa Fe National Forest

Dalton Canyon Restoration Project

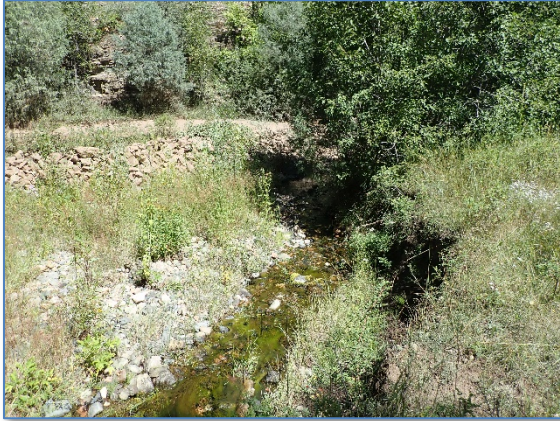
Photograph 1. Bank erosion and road encroachment.

A preliminary assessment of the creek shows substantial relocation of the channel and severe erosion, which resulted from the 100-year-plus flood event of September 13, 2013. The erosion is so severe (see Photograph 1) that it cut through the bank at one point and followed the old FR 123 road bed. Additional erosion and degraded water quality is occurring as a result of recreational damage (see Photograph 2, 3, 4, 5, and 6). Access to the creek by vehicular traffic has eliminated riparian vegetation in some areas and is contributing to more erosion in the creek channel and ultimately to degraded water quality and aquatic habitat. The recreational pressure was exceptionally high in the summer of 2020 with substantial trash being left behind, severe soil compaction, sewage on the ground, and an oil spill in the creek.

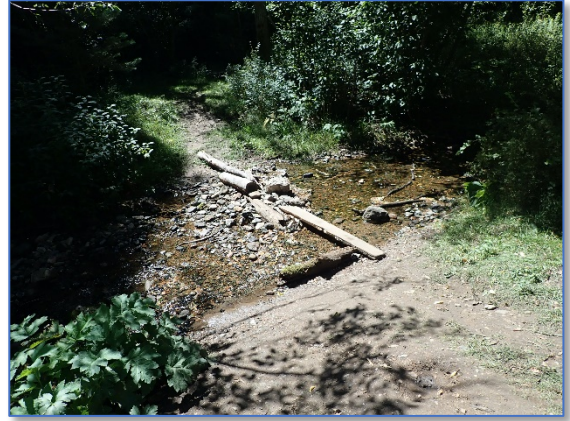
Photograph 2. Recreational damage to creek bank.

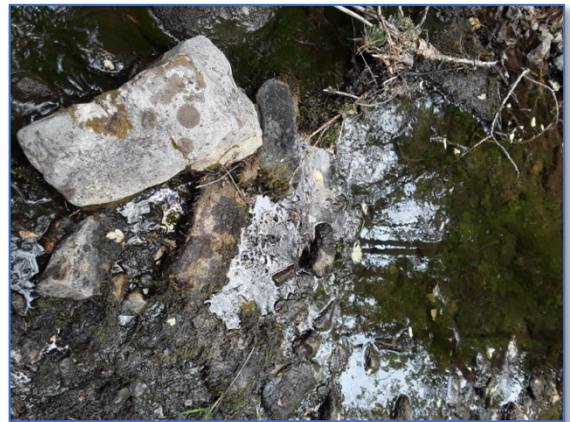
Photograph 6. Oil slick from spill.

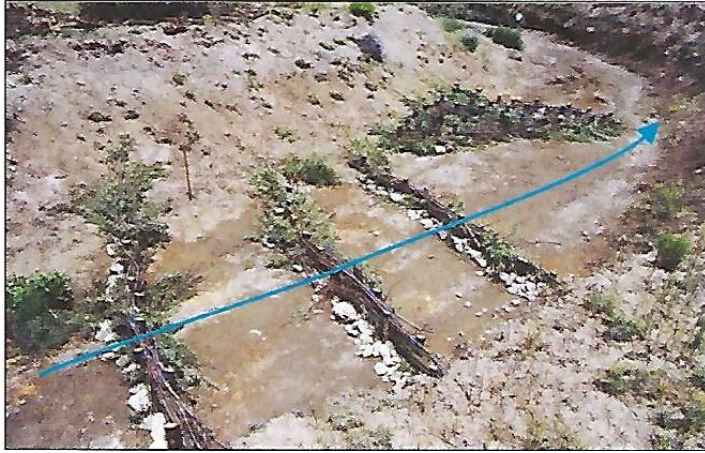
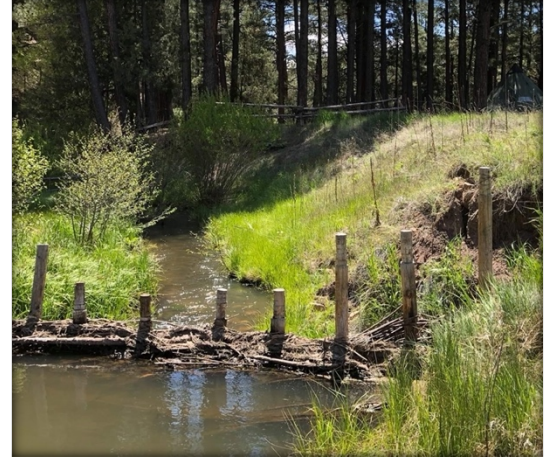
3. **Beaver Dam Analogues** – Wooden pickets are driven vertically into the ground and then willows are woven back and forth in a basket-like structure. This structure slows and spreads the water flow of the creek across the floodplain and valley bottom. The willows are able to capture sediment and grow roots, anchoring the structure in place.

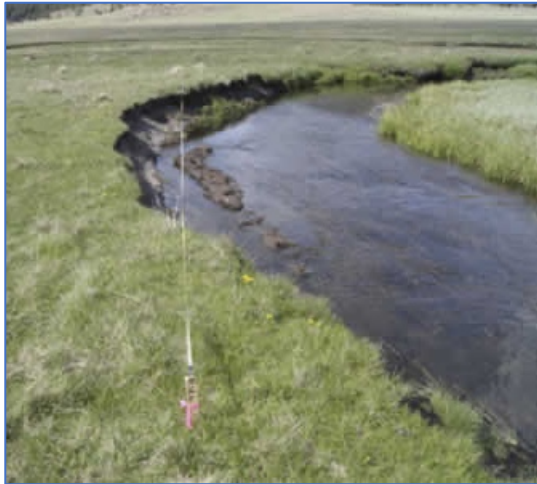
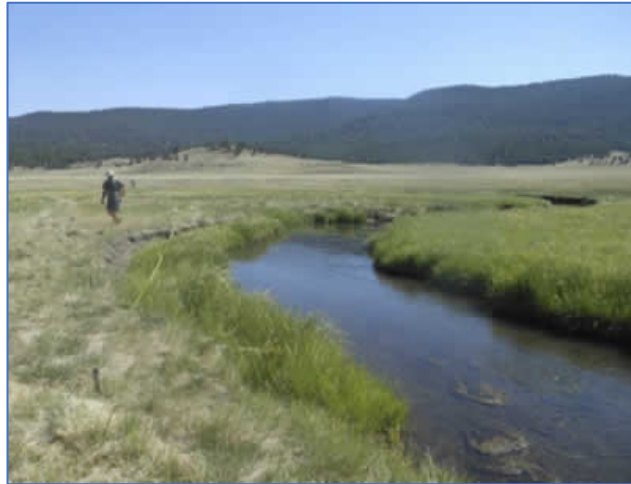
6. **Bankfull Bench** – Riparian vegetation would be removed from the top of the bank and transplanted along the edge of the creek at the toe of the slope. The steep bank would be laid back to a less steep angle. The vegetation narrows the creek's width, provides overhanging vegetation and reduces turbidity by buffering bare soil, thus reducing sediment input from erosion.

This location has two 4-5' tall, 60-100' long eroding banks that were caused by the 2013 flood. These two banks would be repaired using a low-impact rubber tracked excavator to cut back the bank at a less steep angle at the toe of the slope. A 5-foot-wide section of riparian vegetation including willows, rushes and sedges would be transplanted at the toe of the slope. In addition, an abandoned channel would be restored that would raise the water table throughout the valley bottom and sub-irrigate riparian vegetation. Rock structures and earthen berms would be used to anchor the restored channel and prevent further erosion.
